**PRELIMINARY ASSESSMENT/
VISUAL SITE INSPECTION**

**SESTER AND SON
KIRKLAND, ILLINOIS
ILD 106 923 360**

FINAL REPORT

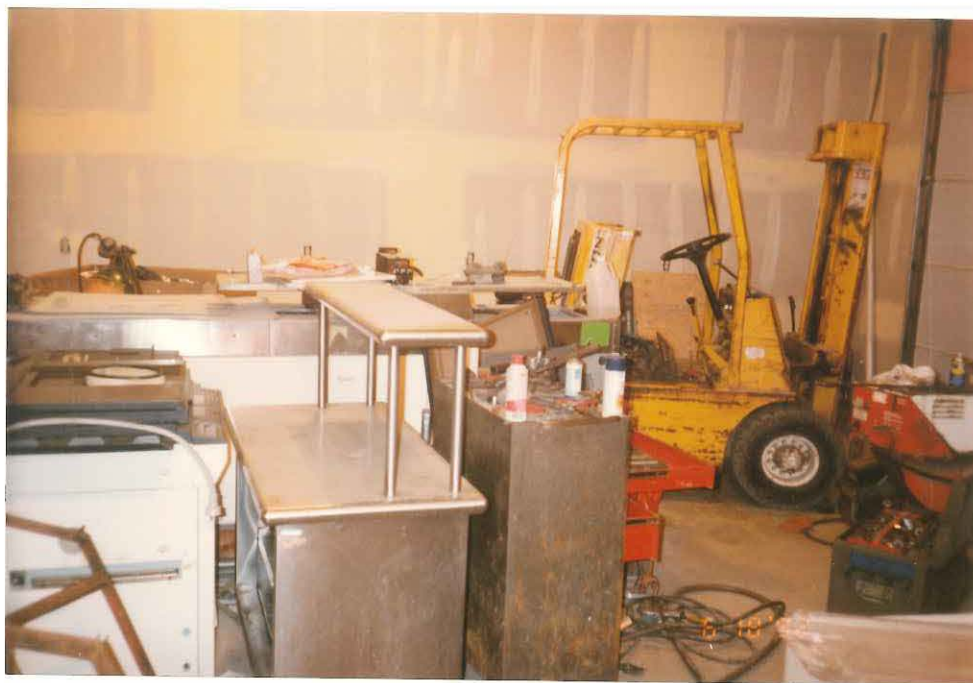
Photograph No. 3

Description: Inside the facility building showing the northwest corner of the building.

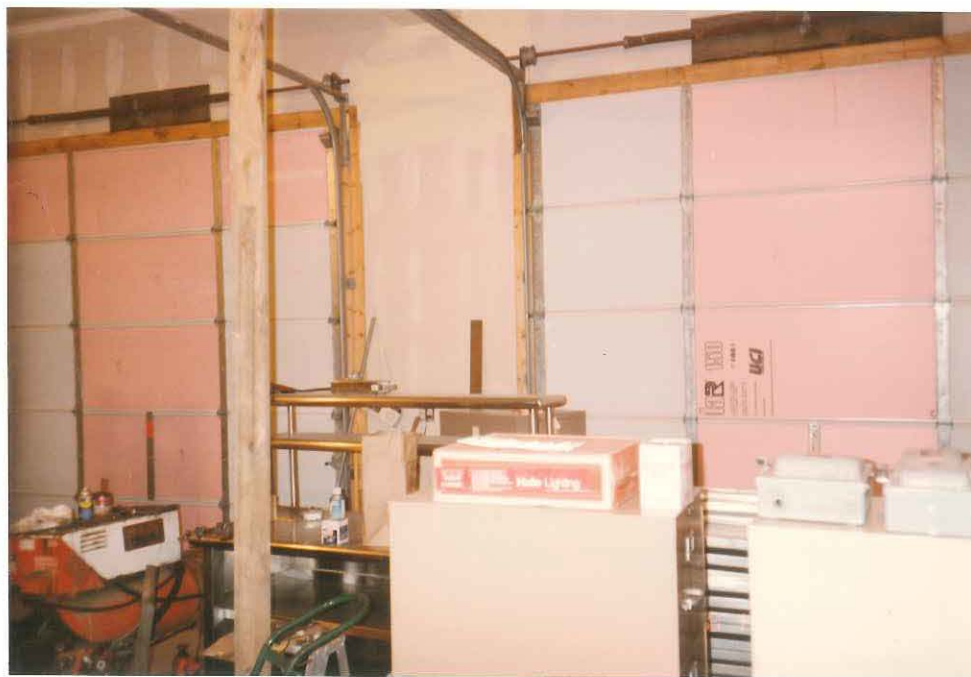
Photograph No. 4

Description: Inside the facility building showing the northwest section of wall.

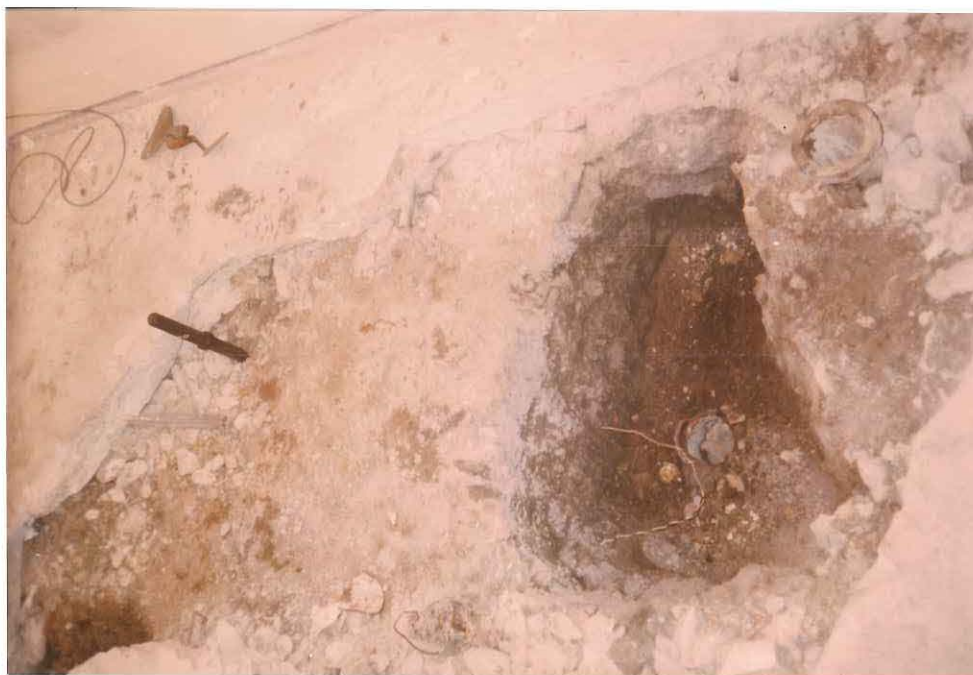
Photograph No. 5

Description: Inside the facility building showing the soil pipe from the bathroom to the Kirkland sewer system.

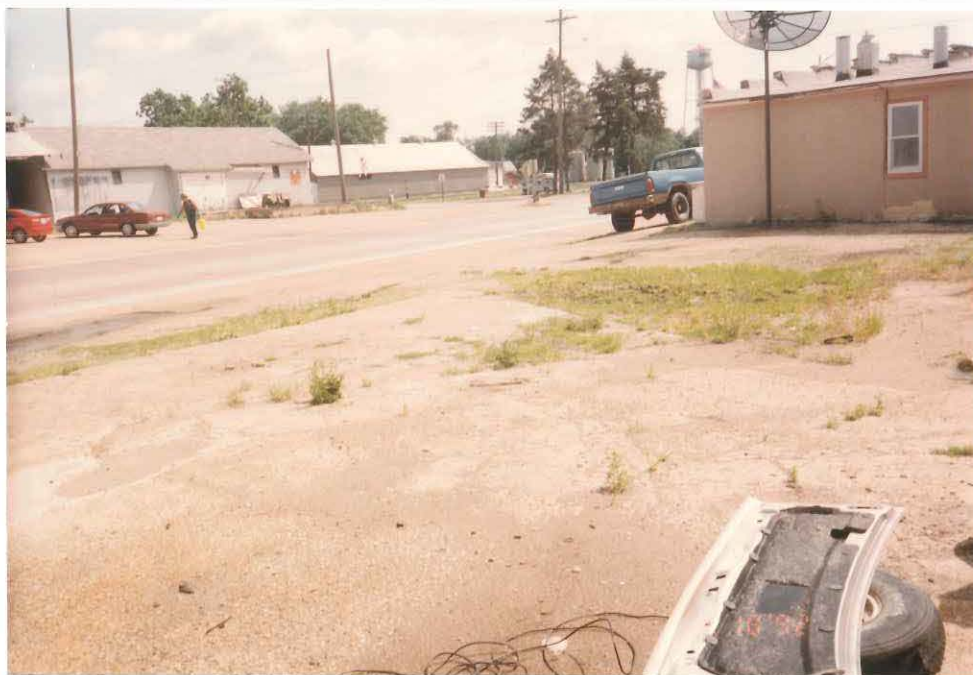
Photograph No. 7

Description: Outside of the building on the north side showing the cement pad and Route 72. This is part of the area where the limestone gravel and soil was excavated.

Recommendations: Although the facility is exempt from RCRA interim status standards, corrective actions for the facility may be pursued under regulations of the CERCLA program. RAI recommends that ground water and on-site soil sampling be conducted at SWMU 1. Also, RAI recommends surface water sampling for Bull Run stream. Ground water sampling is recommended because there has been a release to on-site soils and because the seasonal spring water table is generally 1 to 3 feet below the surface in Elburn silt loam soils. Surface water and on-site soil sampling is recommended because of the history of releases to the soil and surface water at the facility. RAI also recommends that a fence be constructed around the facility that limits the accessibility of the area.

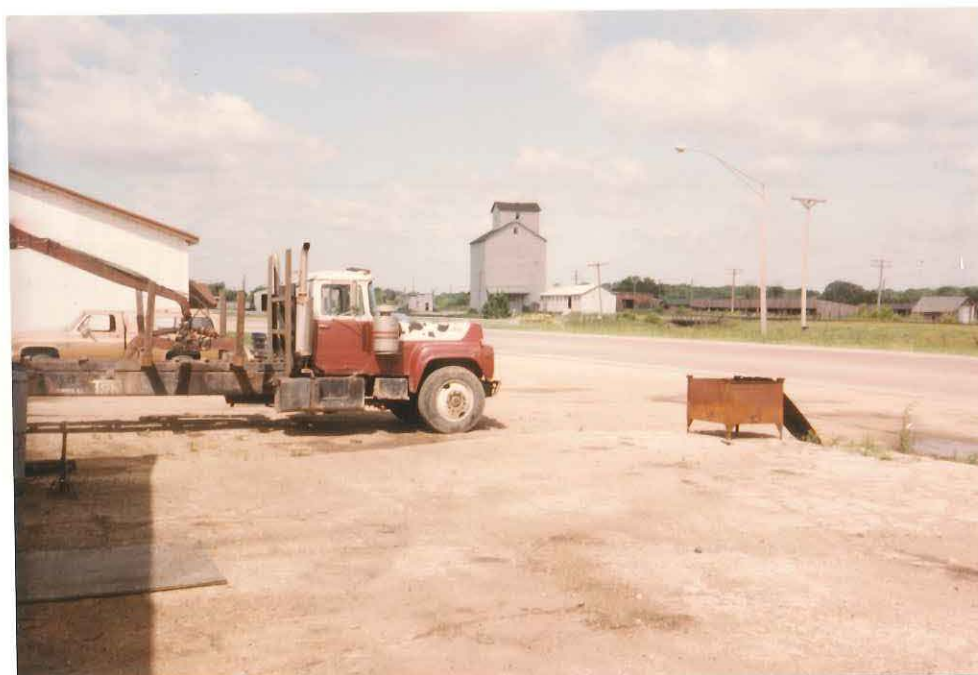
Photograph No. 8

Description: Outside of the building. Note Route 72 along the north side. This is part of the area where the limestone gravel and soil was excavated.

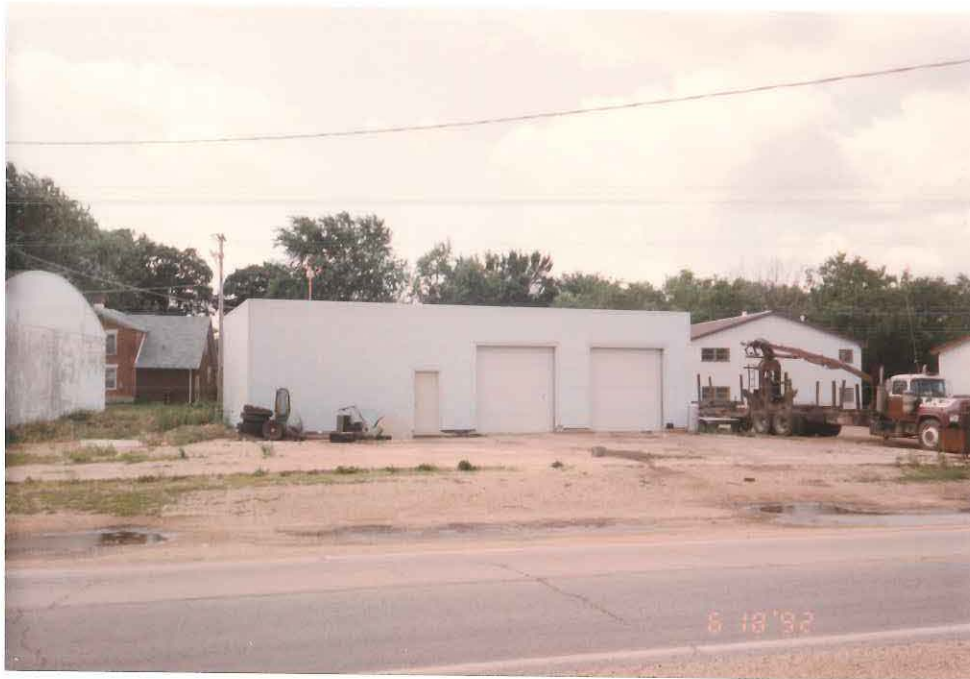
building on the north side there are some tires, miscellaneous equipment, and one battery. There was nothing stored along the east side of the building. A propane tank and a truck were along the south side of the building. A truck, an augur bit, and a truck topper were west of the facility building. RAI noted no evidence of release during the VSI (see Photographs No. 1 through 11).

Photograph No. 11
 Orientation: South
 Description: SS facility showing the whole parcel and buildings.

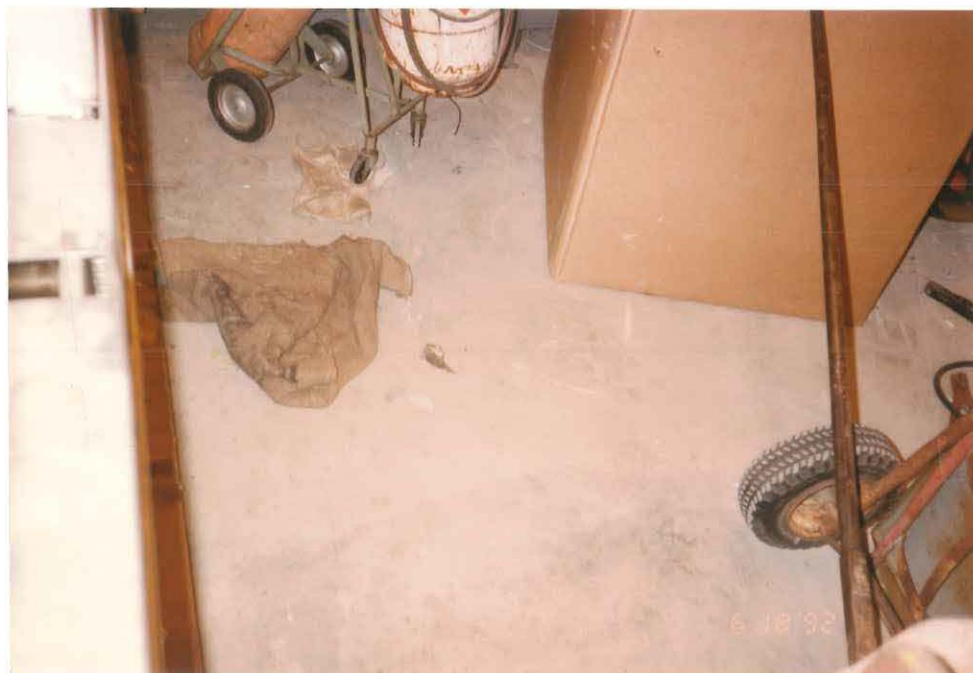
Observations: The outdoor inground steel tank was removed prior to the facility ceasing the lead/acid battery reclaiming operations. The location of this former outdoor steel tank could not be determined during the VSI. The indoor stainless steel capture tank was removed as part of Norman Sester's closing of the lead/acid battery reclamation operation. The exact dates that the tanks were removed are not known. RAI noted no evidence of release (see Photograph No. 12).

Photograph No. 12
 Orientation: South
 Description: Inside the facility buildings showing the former location of the Sulfuric Acid Neutralization Tank.

RAI recommends no further action for this unit. These tanks have been removed from the SS facility and there has been no documented release from them.
